# CITY OF WATERTOWN

### CONSERVATION COMMISSION MEETING WEDNESDAY, APRIL 6, 2022 AT 7:00 PM AGENDA

# Watertown Dam Removal Feasibility Study

On the Charles River  
Dam No. MA00456  
Watertown, Massachusetts  
June 30, 2021  
Final Draft

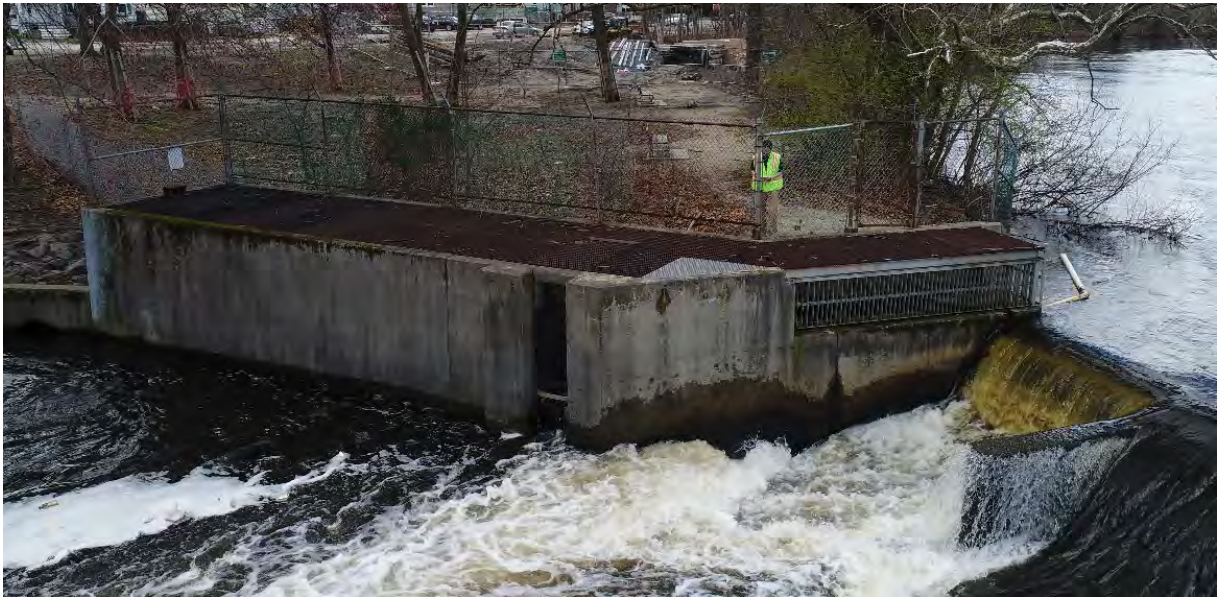
**FIGURE 2-2**  
**Photograph of the Fish Ladder**

Assessment of the performance of the existing fish pass during a 2011 study determined that the fish ladder is functioning in a limited capacity due to a number of concerns including hydraulic conditions at the entrance and exit of the fish ladder, existing stop log boards located at the fishway entrance that are higher in elevation than the spillway, poor attraction flow through the fish ladder and at the fishway entrance, and shallow water depths at the downriver fish entrance (Stantec, 2011). The CRWA estimates that as many as 300,000 river herring attempt to migrate up the Charles River annually, not counting other species such as American shad, American eel, or smelt, which also utilize the ladder. This equates to approximately 15,000 fish per day utilizing the Watertown Dam fish ladder. MADMF video monitoring in 2013 and 2014 provided counts of individual species passing through the fish ladder as presented in Table 2-2. These counts were

A follow-up acoustic tag study by the MADMF (MADMF, 2017) found that of the nearly 100 American shad that were tagged none were able to ascend the Watertown Dam fish ladder. Personal correspondence with Ben Gahagan of MADMF indicates that the studies to date have conclusively shown that the Watertown Dam poses an impediment for anadromous fish, particularly spawning American shad. Fish have difficulty utilizing the fish ladder because it is located on the river-right bank of Charles River whereas the deepest waters flowing over the dam are located on the river-left bank (MADMF, 2018).

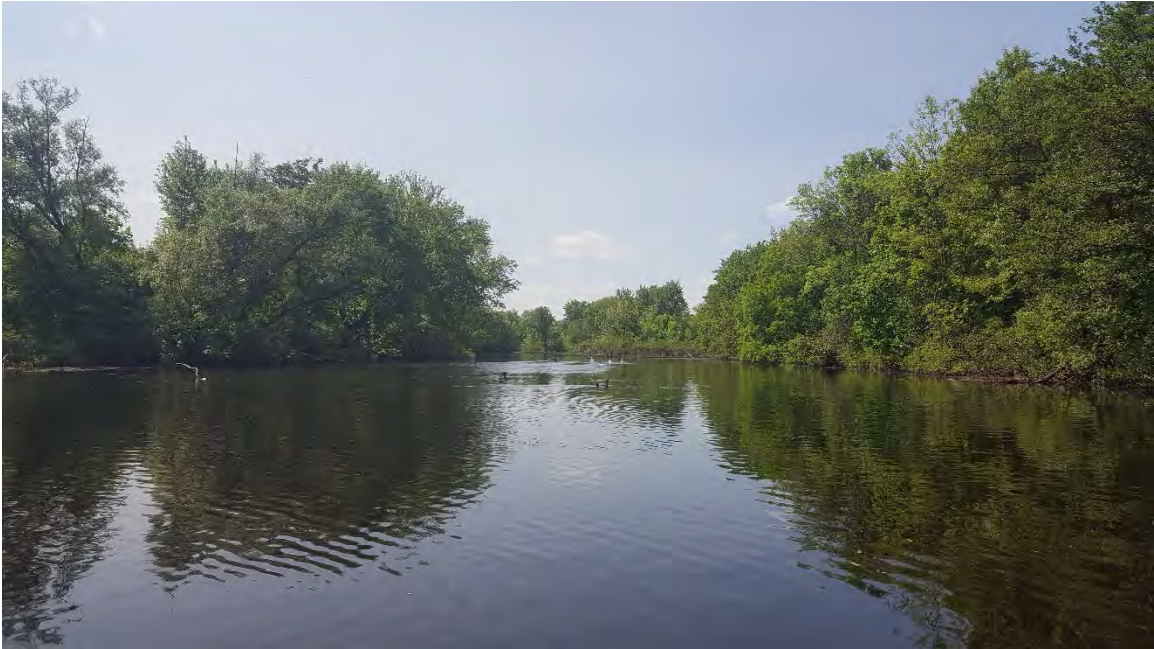
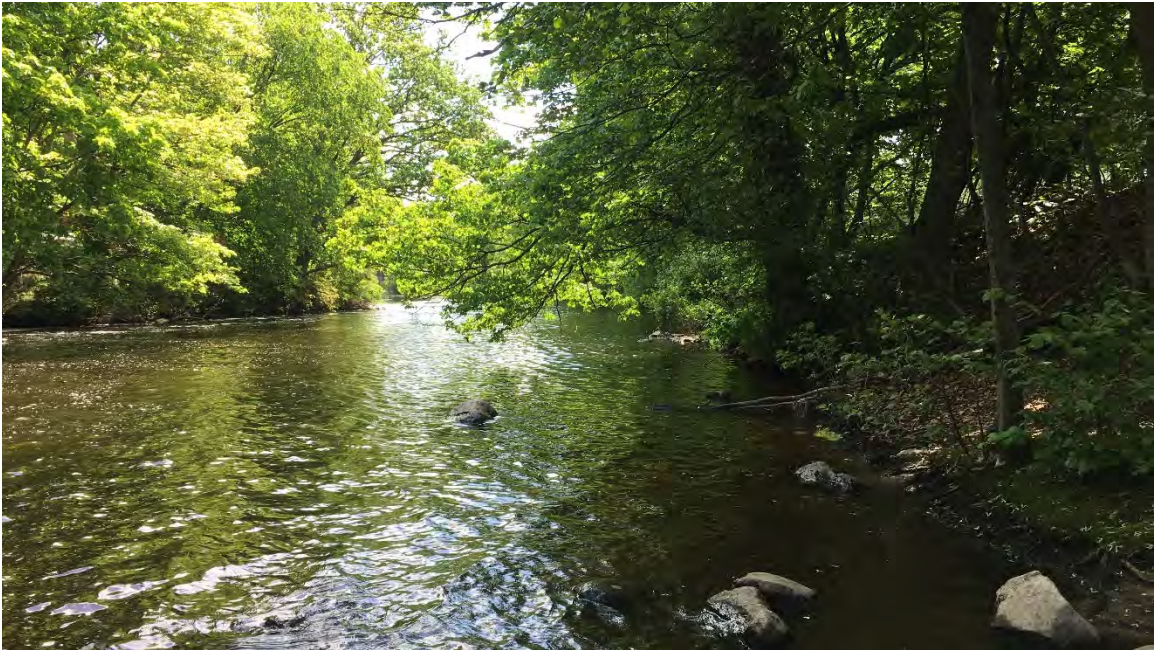
**FIGURE 3-4**  
**Typical Riverbank Vegetation Upriver (Above) and Downriver (Below) of Watertown Dam**

Water flow in the Charles River upriver of the dam is characteristically deeper and slow-moving under normal flow conditions due to the presence of the dam. The vegetated banks and riparian corridor are protected by well-established and large floodplain trees. Generally, more fallen trees and debris were noted upriver of the dam than downriver. The photographs in Figure 3-4 on the following page represent typical channel sections both upriver and downriver of the Watertown Dam.

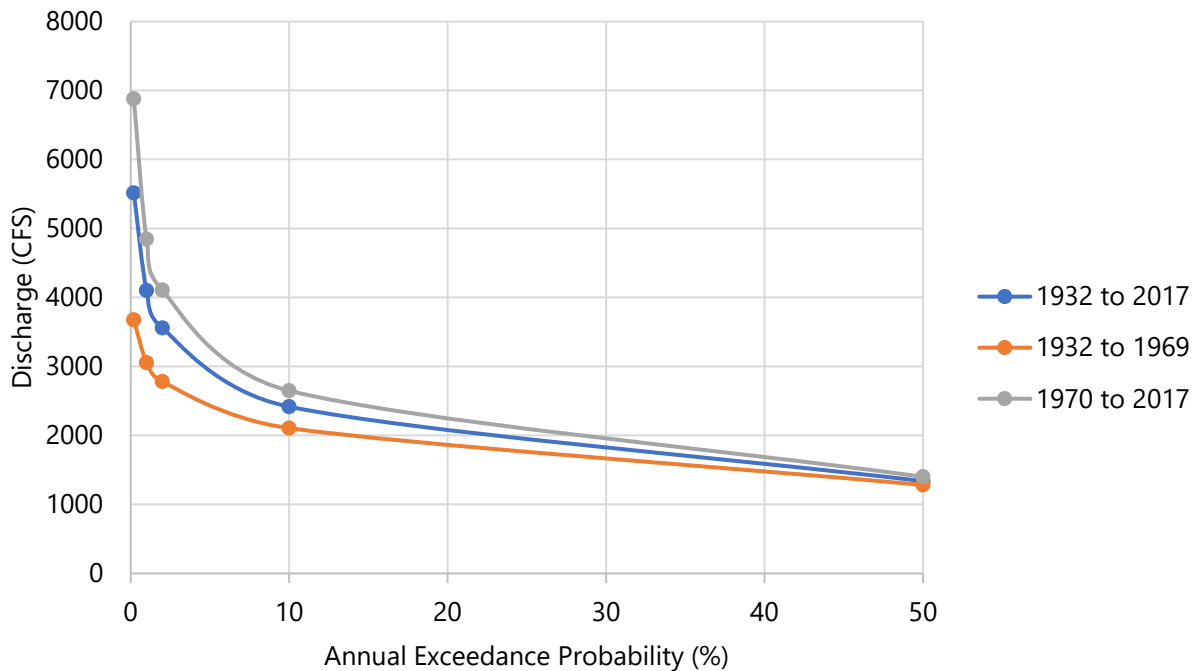
**FIGURE 4-3**  
**Bulletin 17B Analysis on Gauge 01104500 for**  
**1932-2017, 1932-1969, and 1970-2017**

magnitudes around 1970 (Collins, 2009). Project design guidelines published by Collins through the NOAA Fisheries Service recommend the following (Collins, 2011):

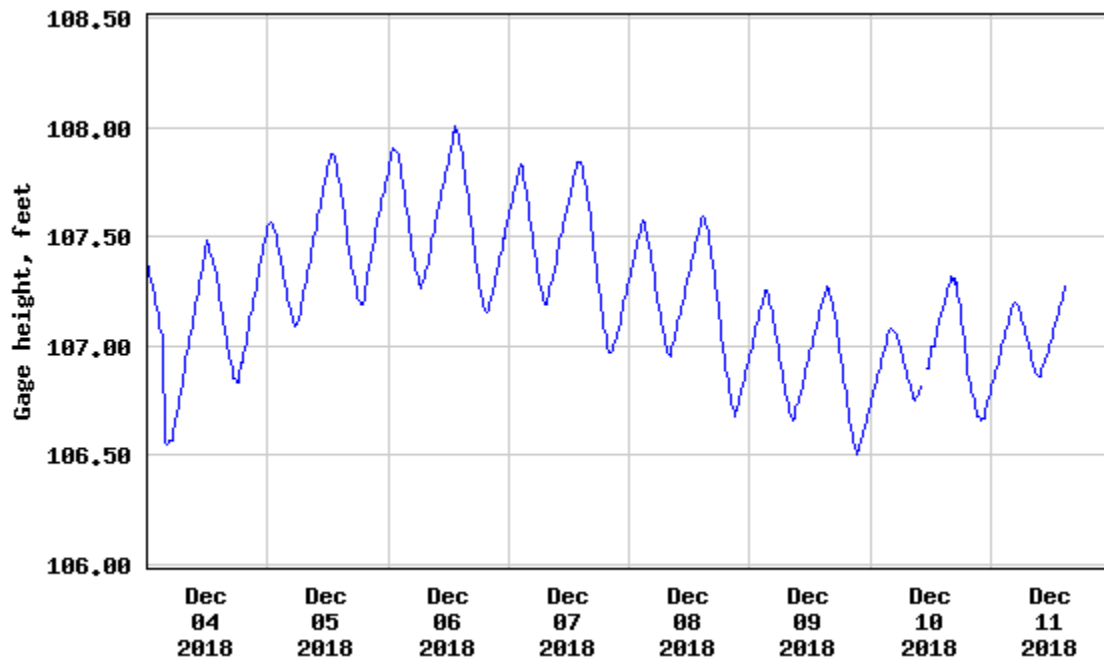
**FIGURE 5-1**  
**USGS Gauge No. 01104715 Charles River at the New Charles River Dam in Boston**  
**December 2018**

As a result of its daily operation, water levels in the Charles River Basin under most normal flow scenarios remain between those elevations of 0.05 feet NAVD and 2.05 feet NAVD; therefore, this elevation range was used as a downstream boundary condition for various low-flow conditions in the modeling and analysis. Although there may be outliers in other years, this was chosen as a good approximation for typical boundary conditions for low flows during the summer months. Specifically, the fish passage assessment and bank exposure assessments (described later) were performed with a range of flows in order to "bracket" the range of normally expected conditions. The higher flows used in those analyses utilize the higher boundary condition of 2.05 feet NAVD, and the lower flows utilize the lower boundary of 0.05 feet NAVD. The June 50 percent exceedance flow uses the average water surface elevation of 1.05 feet NAVD as a downstream boundary condition.

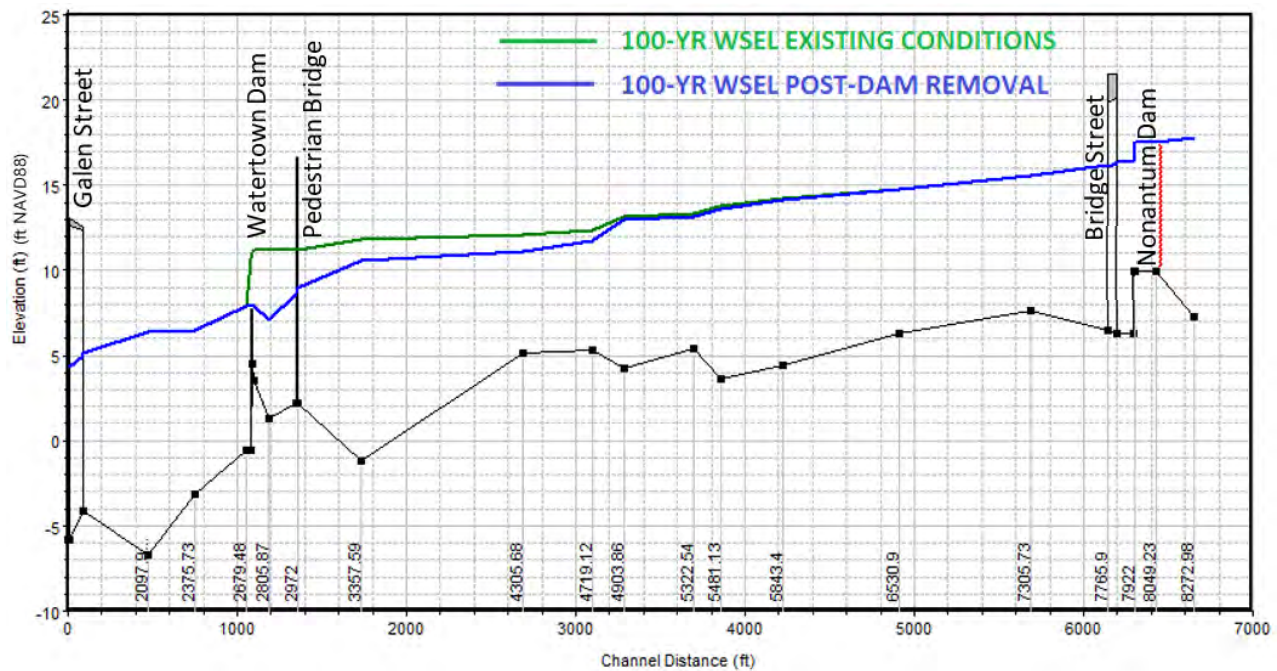
**FIGURE 5-5**  
**Profile of the Charles River Showing 100-year + 30% Water Surface Elevations**  
**Existing Conditions vs. Post-Dam-Removal Conditions**

As is illustrated in Figure 5-5, the model predicts that the 100-year floodplain elevation will drop approximately 3 feet in the vicinity of the dam site, 2 feet in the vicinity of the Corporal Thompson Footbridge, and 1 foot upstream of the pedestrian bridge for a distance of approximately a half mile, or halfway between the Watertown Dam and Bridge Street (Station 4903 as shown in Figure 5-5). This is the limit of impact of water surface elevations, as locations farther upstream of this point are not expected to see any reduction in floodplain elevations or changes in hydraulics. The change in elevation correlates with a commensurate albeit modest change in the extents of the 100-year floodplain.

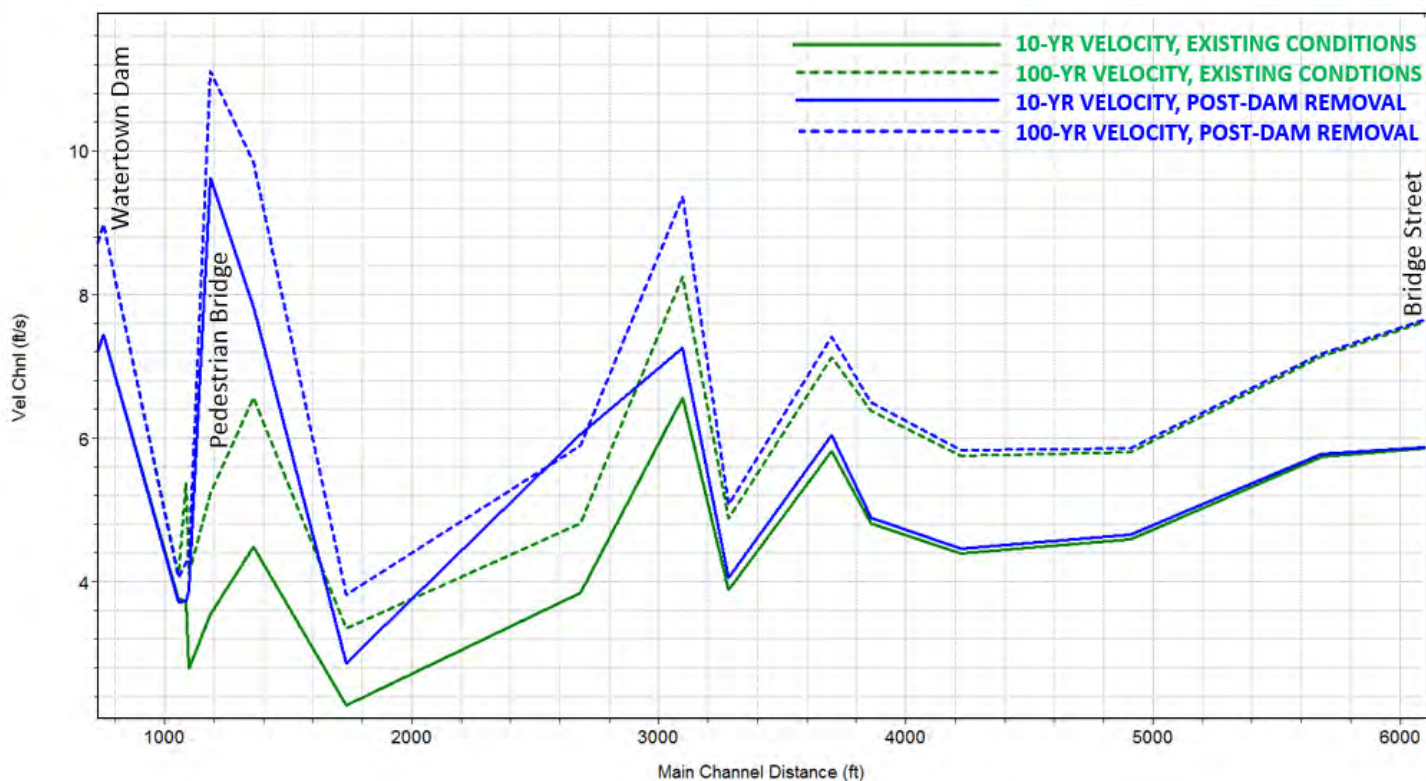
**FIGURE 5-7**  
**Proposed Conditions Predicted Velocities Post-Dam Removal**  
**100-YR +30% and 10-YR +30%**

Modeling results indicate that the existing channel is subject to high velocities for larger storm events, especially downstream of Watertown Dam. A summary of velocities and shear stresses for various flows under existing conditions is provided in Table 5-2.

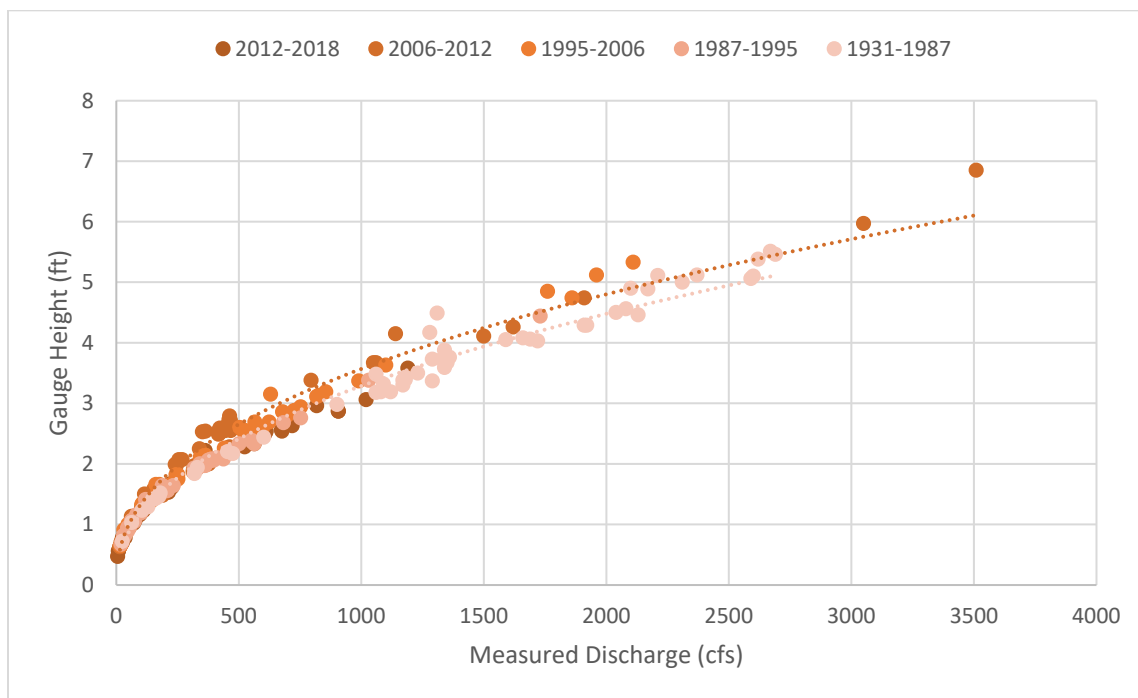
**FIGURE 5-10**  
**Discharge vs. Height at USGS Gauge No. 01104500 Waltham, Massachusetts**  
**Between 1931 and 2018**

The Waltham gauge is located 2.7 miles upriver of the Watertown Dam and does seem to imply that sedimentation in the Charles River is occurring slowly. The trend lines appear to show that discharges of a similar magnitude were associated with slightly higher gauge heights, indicating that the bed of the river may have undergone minor aggradation over time. This implies that there likely is sediment being transported through the system and being deposited in this reach of the Charles River. The downstream-most third of the Charles River has a high level of urban and suburban development in the watershed, which limits how much sediment may be naturally entering the system and likely explains the relatively minor aggradation that seems to be occurring.

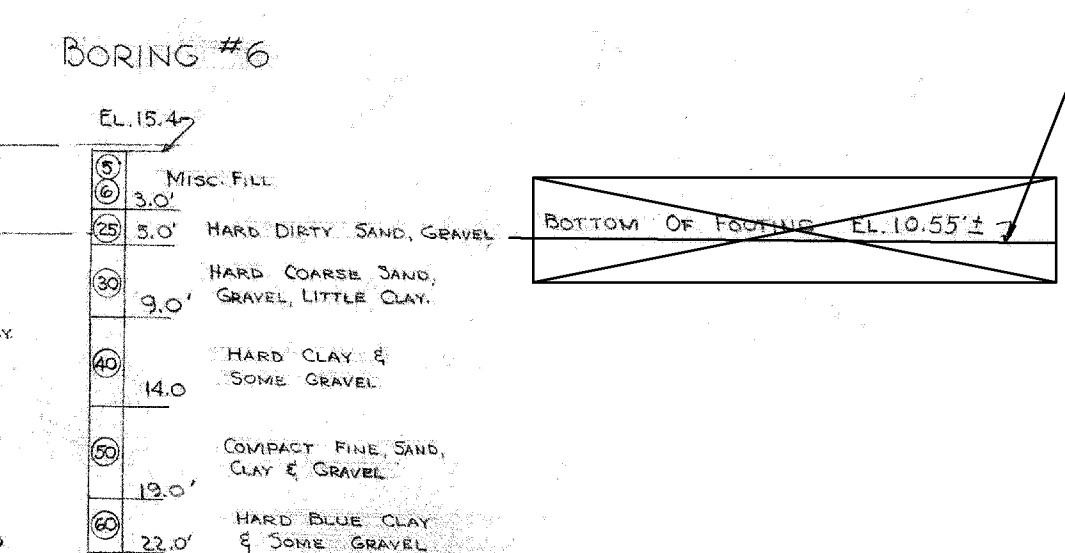
**BORING DATA**  
SIZE 2" SAMPLING PIPE.  
FIGURES IN LEFT HAND COLUMN INDICATE  
NUMBER OF BLOWS REQUIRED TO DRIVE  
2" SAMPLING PIPE ONE FOOT, USING 140-LB.  
WEIGHT FALLING 30 INCHES.  
BORINGS MADE BY RAYMOND CONCRETE  
PILE CO. FEBRUARY 2, 1956.

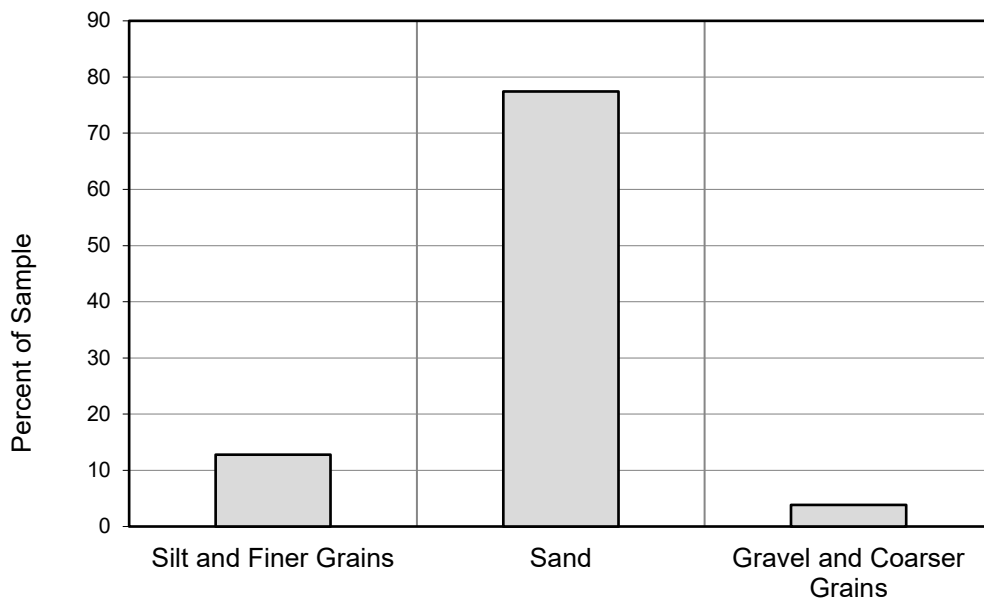
**GRAPH 1-1**  
**S-1 Grain Size Distribution**

Total organic carbon was found to be 3.1 percent, with 56 percent total water.

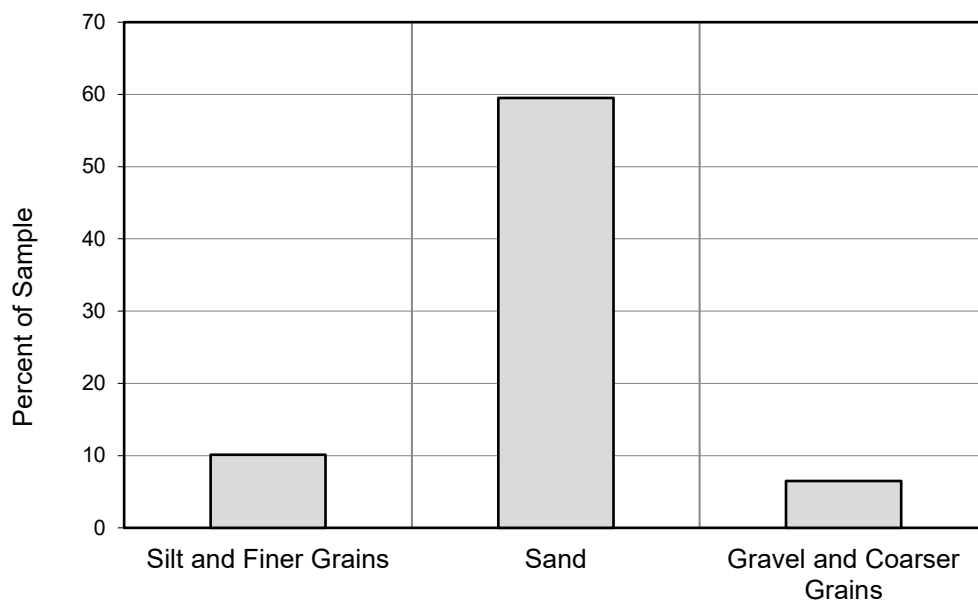
**GRAPH 1-4**  
**S-4 Grain Size Distribution**

Total organic carbon was found to be 8 percent, with 83 percent total water. The sediment depth at the sampling location on the southern bank was approximately 6 inches.

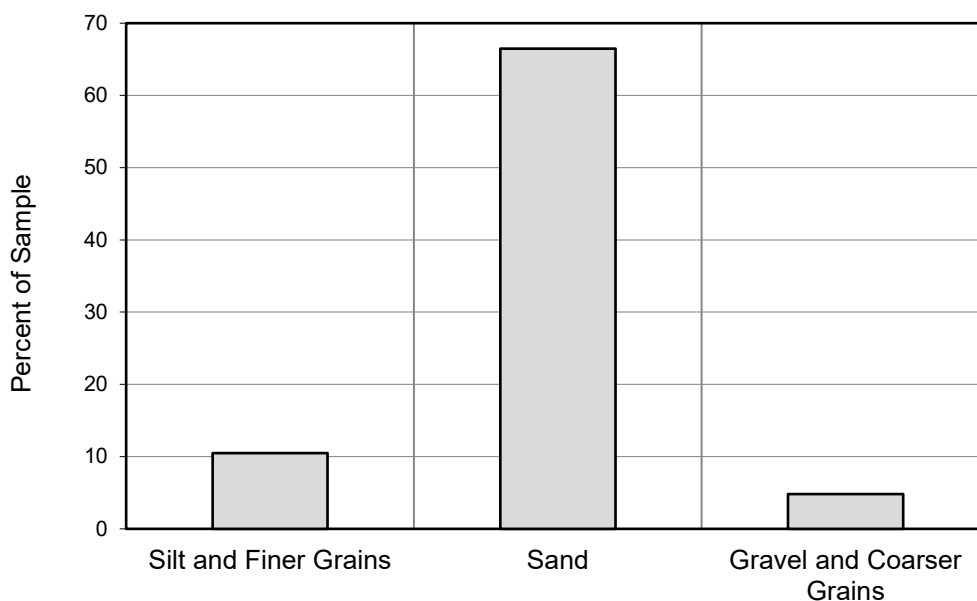
**TABLE 1-5**  
**S-5 Grain Size Distribution**

Total organic carbon was found to be 7.2 percent, with 87 percent total water. There was no significant sediment accumulation in the channel. The sample was collected near the right edge of water.

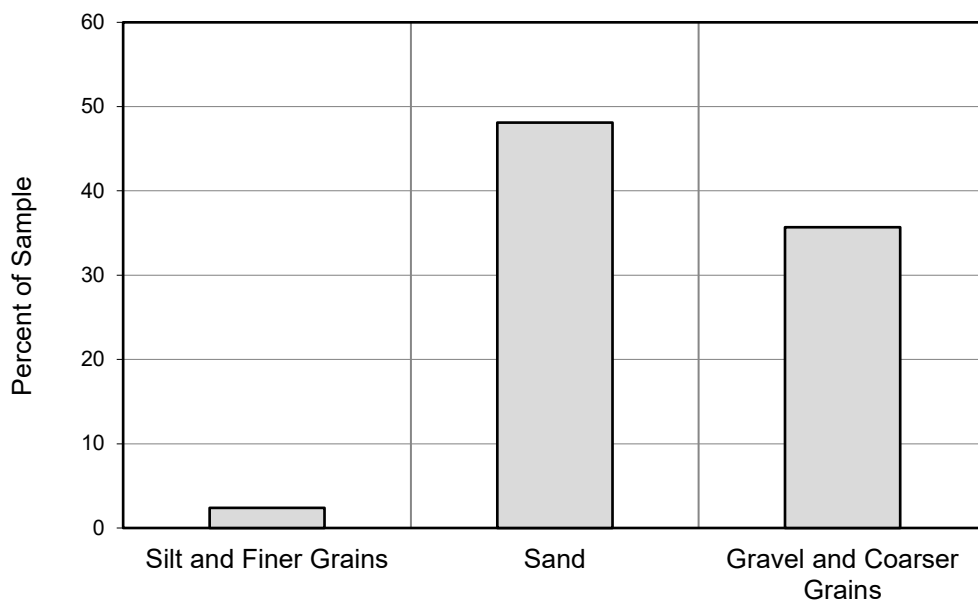
**GRAPH 1-6**  
**S-6 Grain Size Distribution**

Total organic carbon was found to be 8.7 percent, with 87 percent total water. There was no significant sediment accumulation aside from a light gravelly accumulation in the center channel.

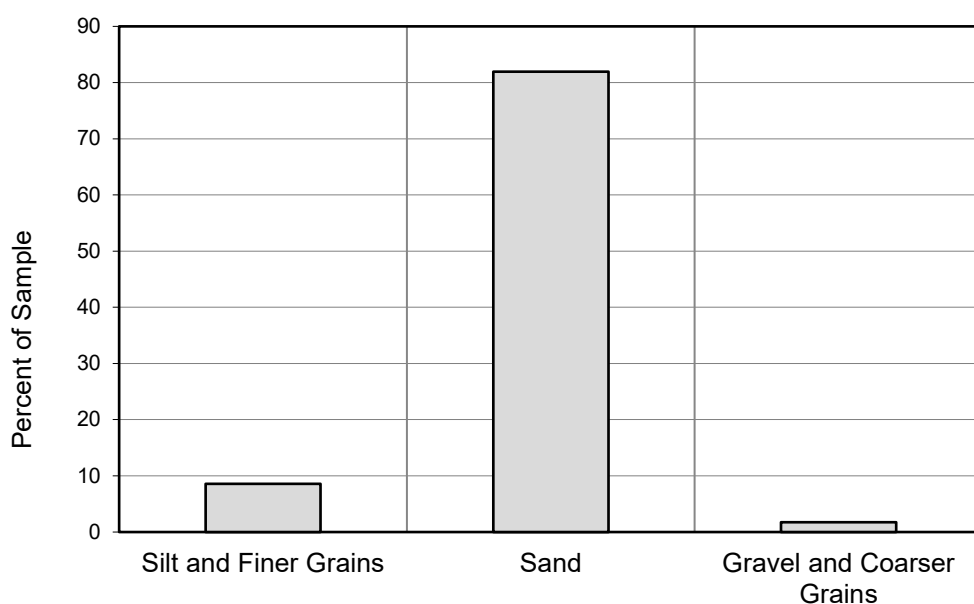
**GRAPH 1-8**  
**S-8 Grain Size Distribution**

Total organic carbon was found to be 2.2 percent, with 35 percent total water. There was approximately 3 feet of sediment near the right edge of water where the sample was gathered.

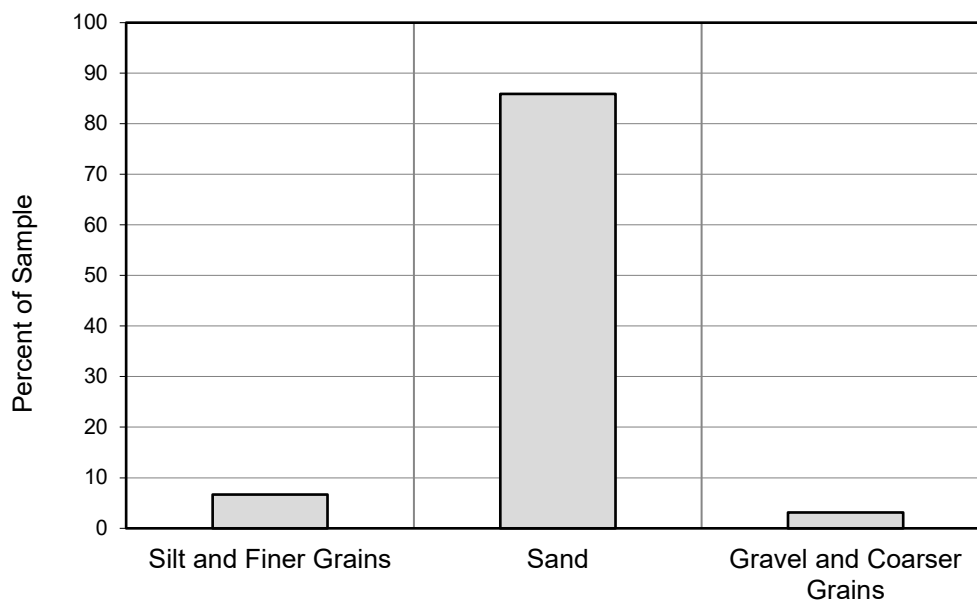
**GRAPH 1-9**  
**S-9 Grain Size Distribution**

Total organic carbon was found to be 2.3 percent, with 51 percent total water. There was approximately 2.5 feet of sandy sediment in the center channel in this area where sampling occurred.

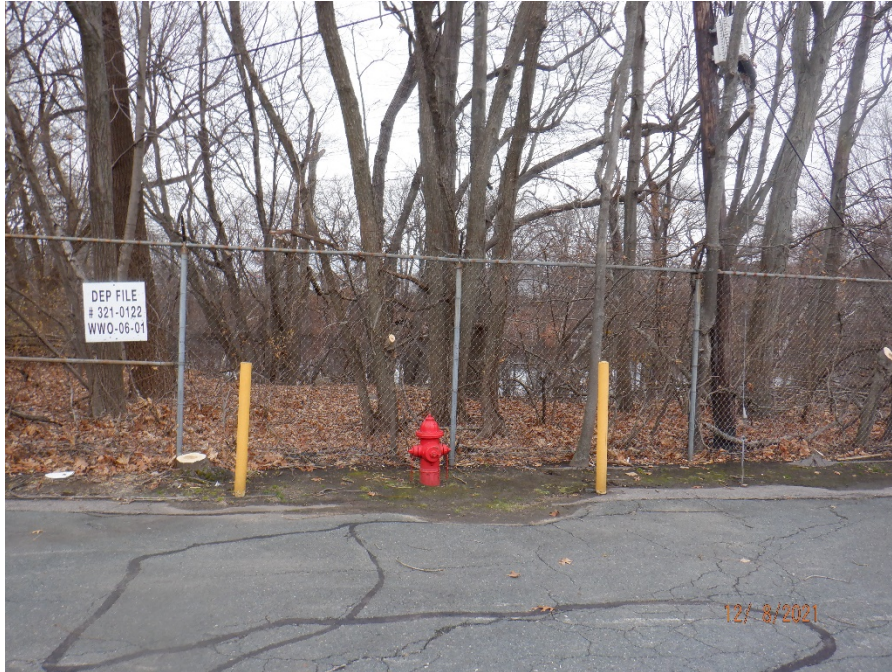
Photograph 1: View north of paved area requiring repair; Walker Pond and associated wetland fringe in distance beyond fence.

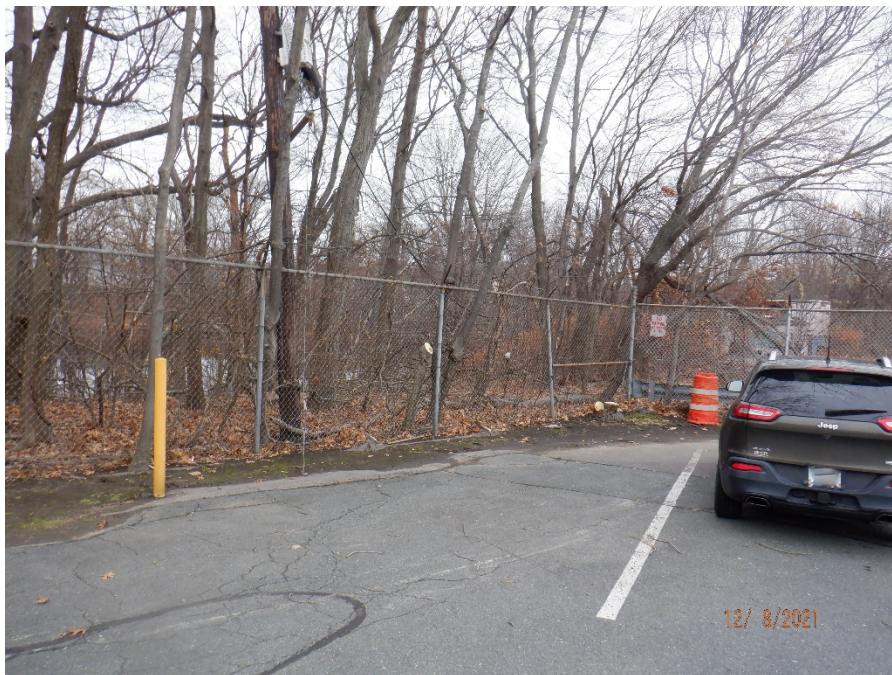
Photograph 2: View north adjacent to Photograph 1.
